## Plug in the vent line of the mud gas separator

The following safety awareness alert is provided as part of MR Group's efforts to raise the awareness of industry personnel regarding the hazards and risks associated with oil and gas drilling rigs and operations. We thank our Clients and field teams for sharing the information.

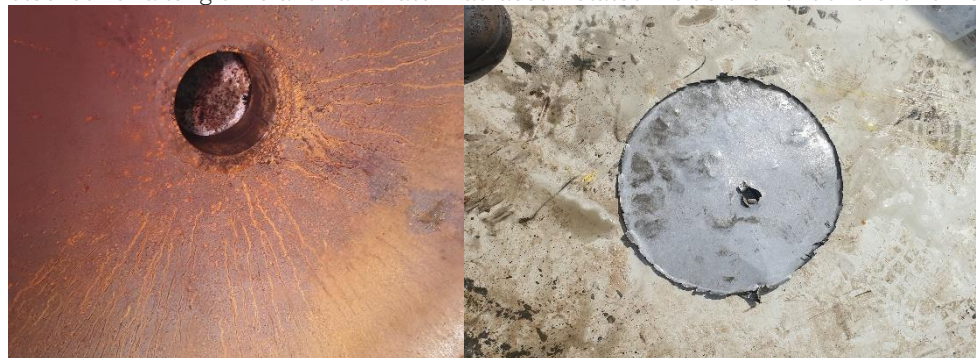
During an internal inspection of a mud gas separator, it was noted that the vent line to the crown level was blocked with what turned out to be a metal plate at the gas outlet flange. The rig in question had just moved to a new location after completing a well to start a new campaign for a new client. When a hole was made in the metal plate a large volume of water ran into the mud gas separator, which indicated that the pipe had been blocked for a long time and rain water had accumulated inside the vent line over time.

Above on the left, a picture taken from inside the mud gas separator showing the metal plate inside the vent line located at the top of the separator. On the right, the picture shows the metal plate after it had been cut and removed from the vent line.

Prior to the previous operation, the rig had been stacked for a long period of time after completion of the new build process in the shipyard. The placement of the metal plate could either be part of the stacking procedure, preventing water from entering the mud gas separator or it was not removed during new build commissioning process and it had been there as part of the packaging from the manufacturer.

Special attention should be given to rigs that have been stacked or are leaving the shipyard after new build.
